**Investigation into the performance of
Statistics House in the 14 November 2016
Kaikōura Earthquake**

March 2017

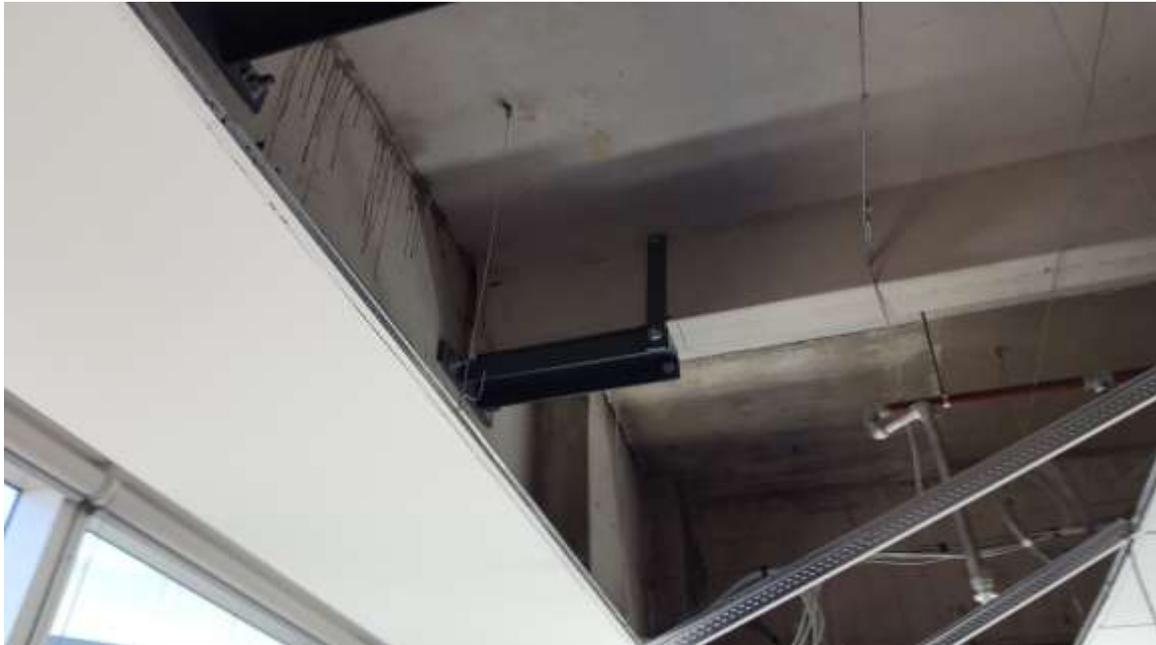
cracking of the floor system. The recommended floor support details were designed with the Building Consent for this work approved. The installation of the catch brackets and diaphragm ties were completed on level 4 and partially completed on level 3 at the time of the Kaikōura earthquakes (Figure 6).

Figure 6: A typical catch bracket retrofitted in 2016

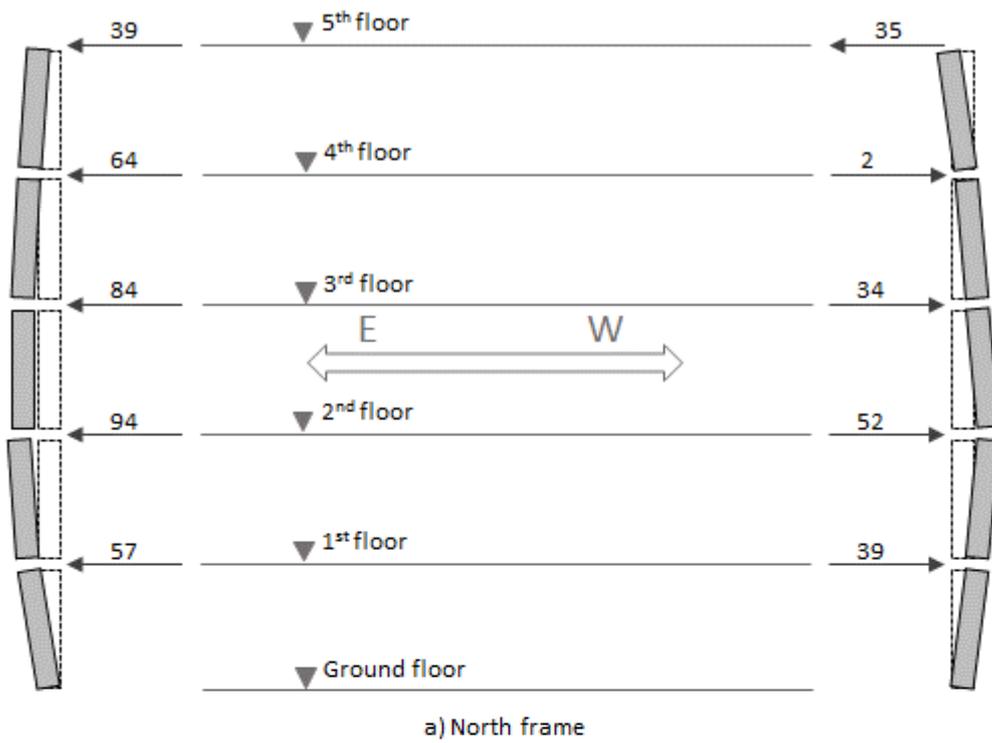
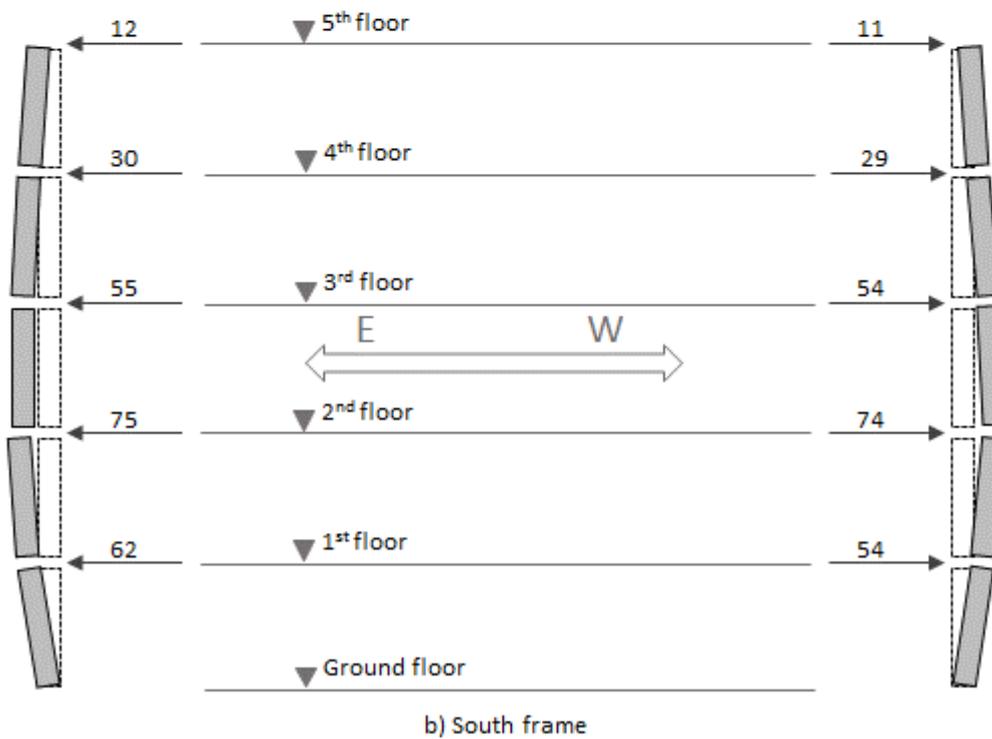
Figure 8: Corner column residual displacements (mm) in the transverse direction (from external survey)

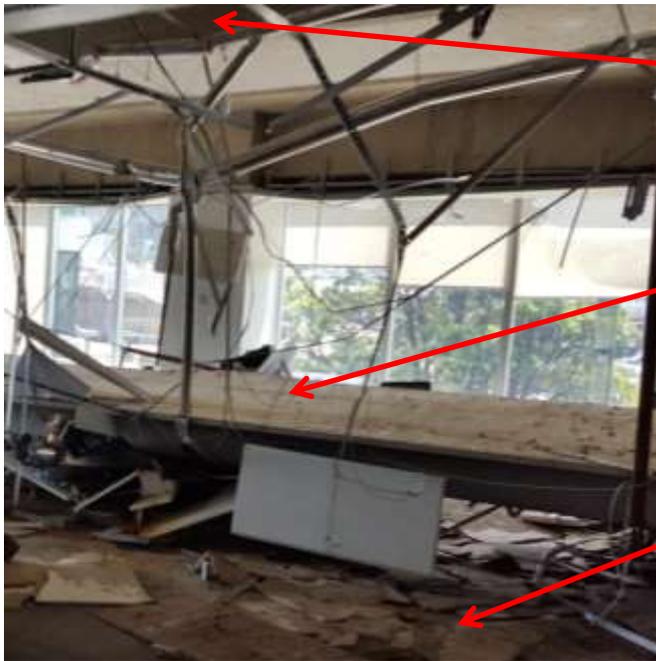
Underside of level 2 floor

Double Tee unit previously at level 2 floor

Level 1 floor

Figure 9: Fallen Double Tee unit at the first floor level

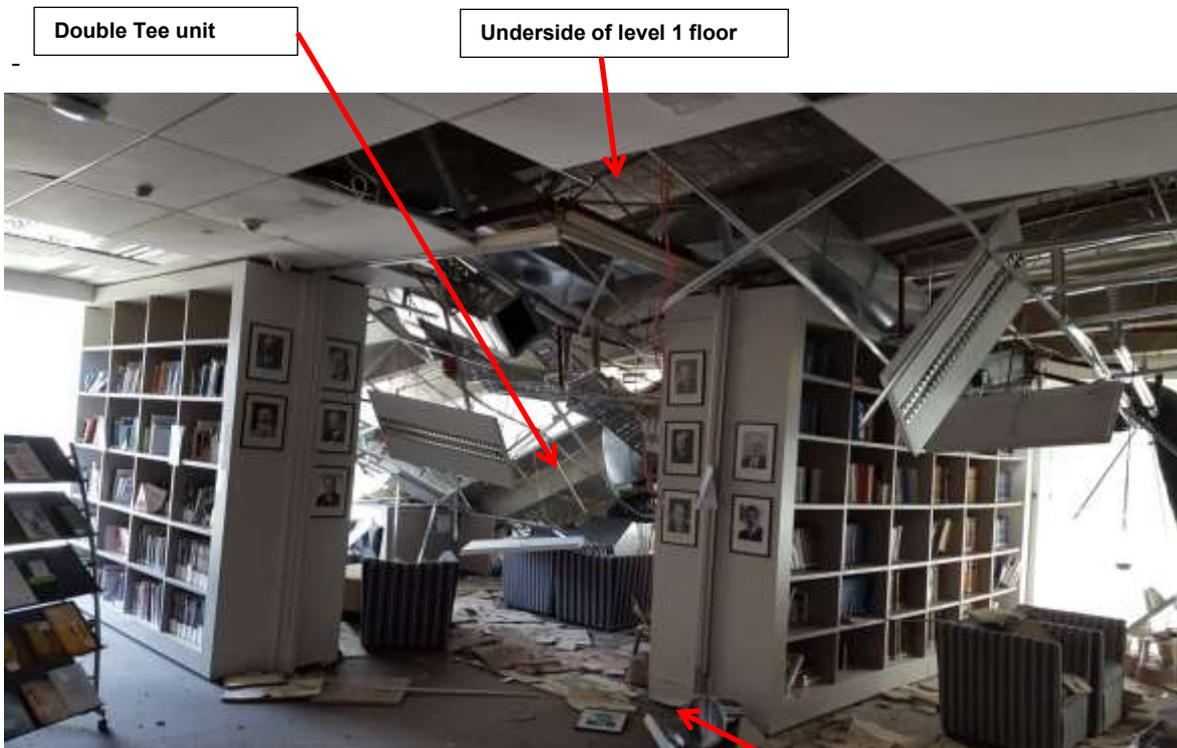
Double Tee unit

Underside of level 1 floor

Ground floor level

Figure 10: Fallen Double Tee units (in background, across the shelving) at ground floor level.

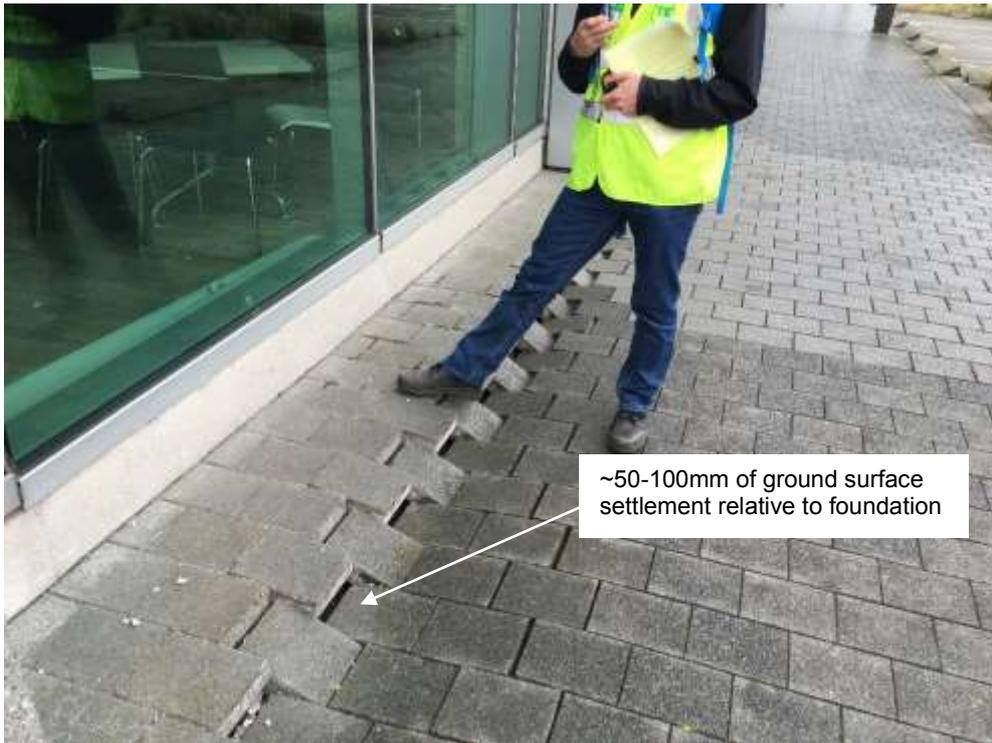
- There is widespread damage to secondary and non-structural building elements and contents.
- Liquefaction-induced ground settlement relative to the pile-supported building perimeter in the order of 50 to 100mm was observed (Figure 11). An estimated 50 to 75mm settlement of the internal ground floor slab was observed. There is also buckling of the footpath pavers near the northeast and northwest corners of the building; possibly indicative of displacement of the large-diameter corner piles in the north-south direction (Figure 12).

Figure 11: Ground surface settlement adjacent to the perimeter of Statistics House

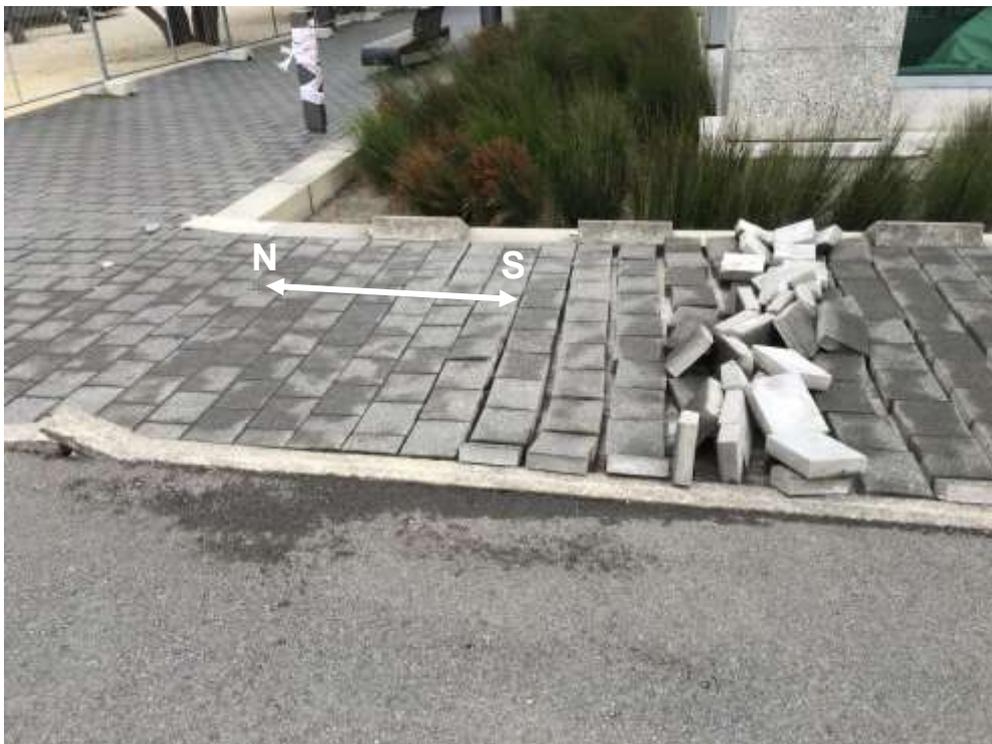
Figure 12: Compression of pavers adjacent to NW corner of Statistics House

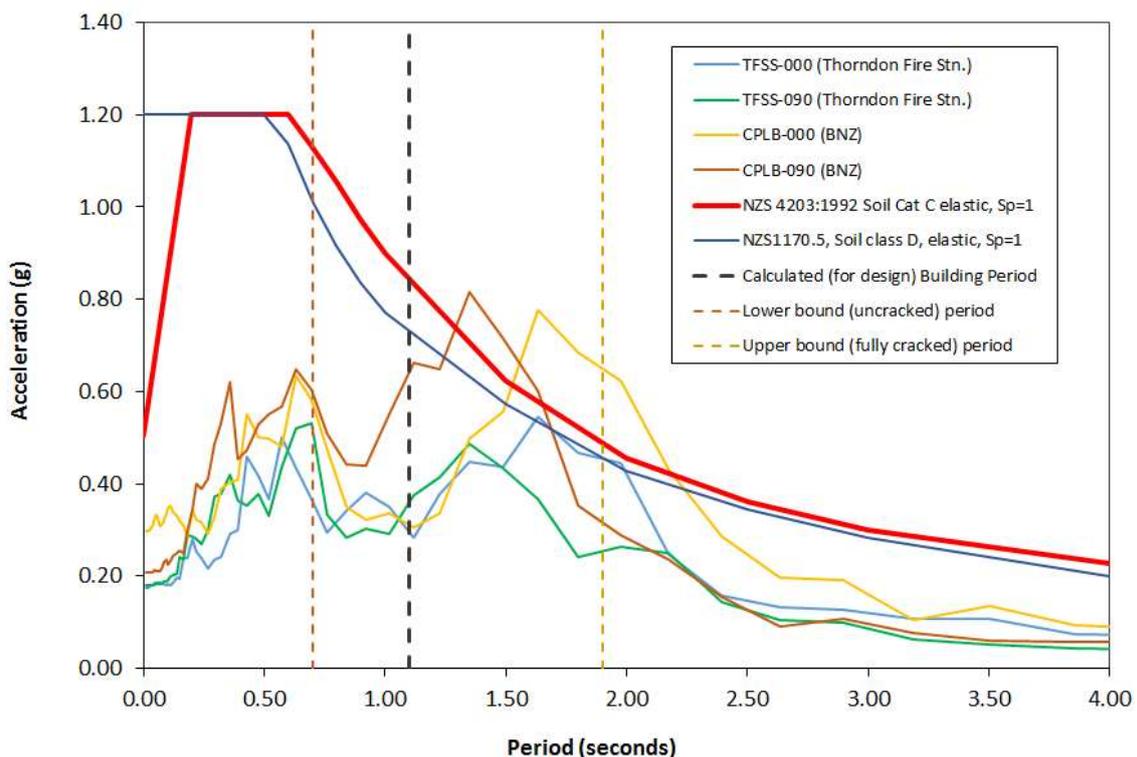
Figure 13 shows that amplification of longer period ground motions, particularly between 0.6 and 2.0 seconds, occurred at the two Thorndon Basin strong motion stations located nearest to the Statistics House site (and others in the Wellington region, refer Figure 7). This amplification has been observed at both stiffer and softer soil sites (NZS1170.5 site subsoil classes C and D) and basin-edge effects have been identified as a potentially significant factor. Neither the previous loadings standard NZS4203 nor the current earthquake actions standard NZS1170.5 require basin-edge effects to be considered.

Figure 13: 5% damped acceleration response spectra at Thorndon Fire Station and BNZ Building strong motion stations

The vertical dotted lines in Figure 13 represent the estimated period shift of the building as it softened and the response increased.

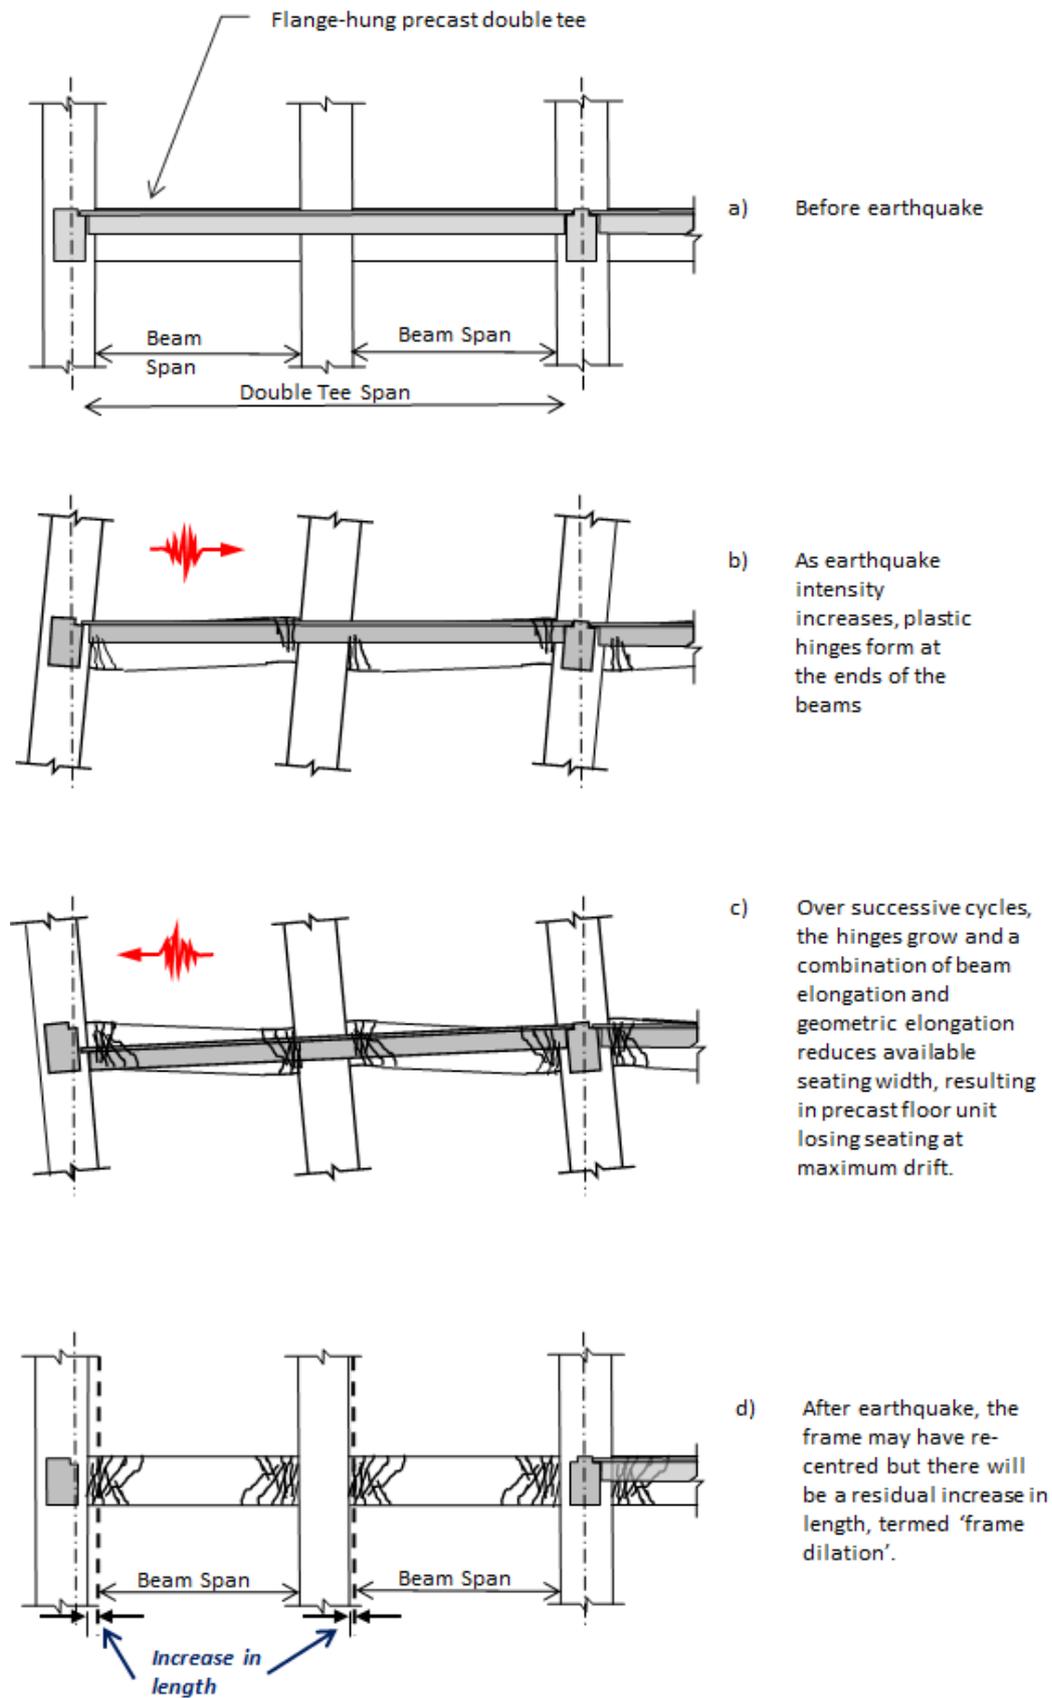
The combination of these two effects is the beam elongation and is illustrated in Figure 14. This leads to frame dilation, meaning that the frame grows in length. Some of this lengthening is not recoverable, even though the building may self-centre to a degree under the cyclic loading (as happened with Statistics House). Beam elongation forces the columns apart at each end of the beam. This then pulls apart any orthogonal beams supported by those columns. If the elongating beam is running parallel to the adjacent floor, it leads to the potential for loss of support to the floor.

Figure 14: Illustration of beam elongation and frame dilation

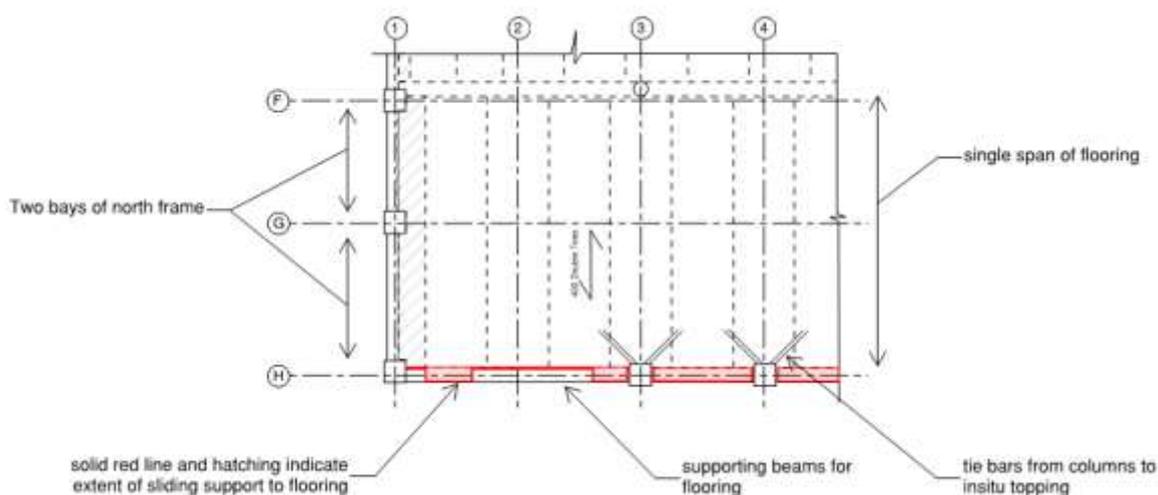
The support conditions at each end of the outer bay varied considerably. The inner end (grid F in Figure 15) had a conventional seating with the topping cast continuously over the supporting beams, whereas the supports at the outer edge (grid H in Figure 15) had a sliding support to prevent the floor constraining the elongation. The effect of this is that the majority of the elongation was concentrated at the outer supports. In Statistics House, there was about 3-4 times the elongation at those outer supports than there would have been with a single frame bay and equal end fixity.

The estimated maximum reduction of seating for the precast flooring units (based on the frame dilation and the multiple-bay frame effect) is approximately 60mm at the second floor.

Figure 15: Part floor plan of northwest corner of typical floor showing two bays of beams per floor span

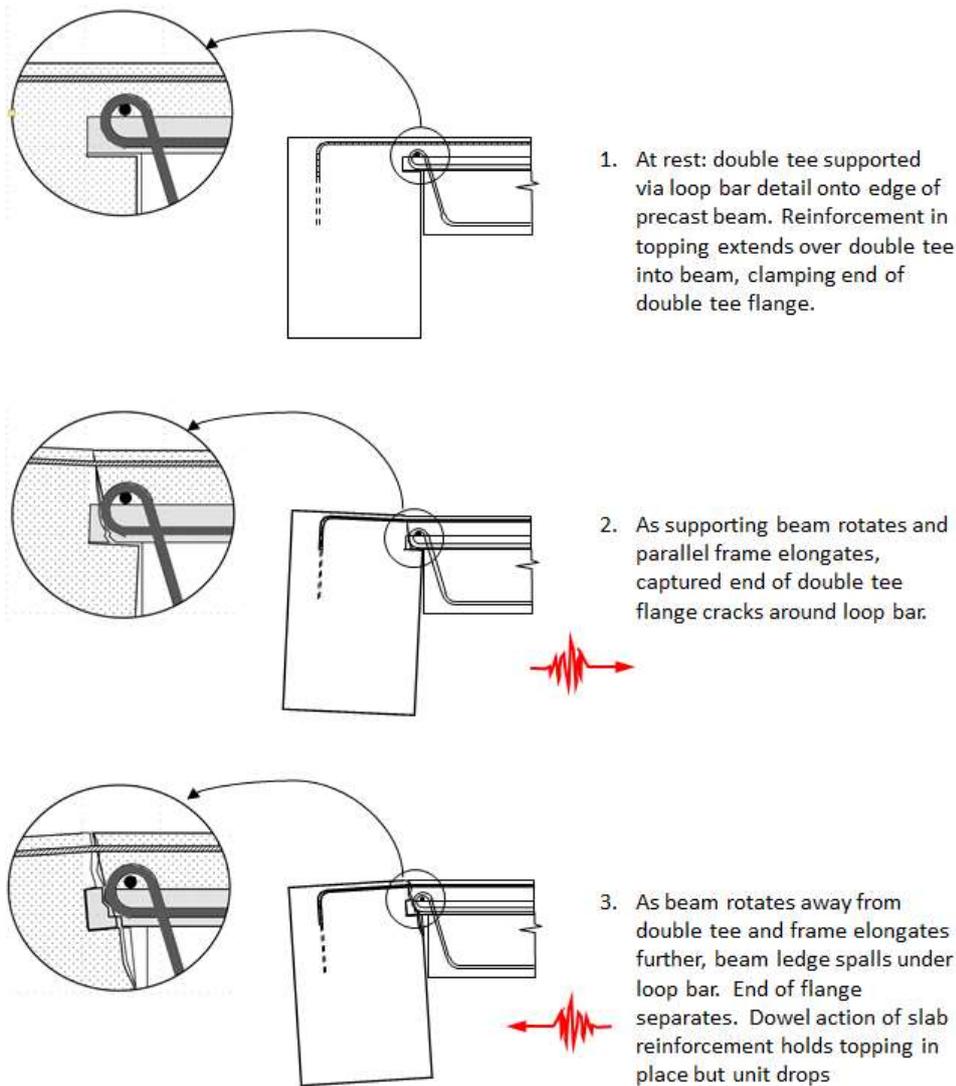
The failures consistently showed the outer edge of the nib breaking off, generally at the end of the loop bar, and in some locations, a small amount of spalling to the supporting beam ledges. This had the effect of shortening the floor units at the same time as the beams were elongating. This failure sequence is illustrated in Figure 17. The length of seating actually achieved during construction would have had no effect on this form of failure, as it is determined by the geometry of the loop bars, not the nib length.

Figure 17: Failure sequence of double tee nib
