**Investigation into the performance of
Statistics House in the 14 November 2016
Kaikōura Earthquake**

March 2017

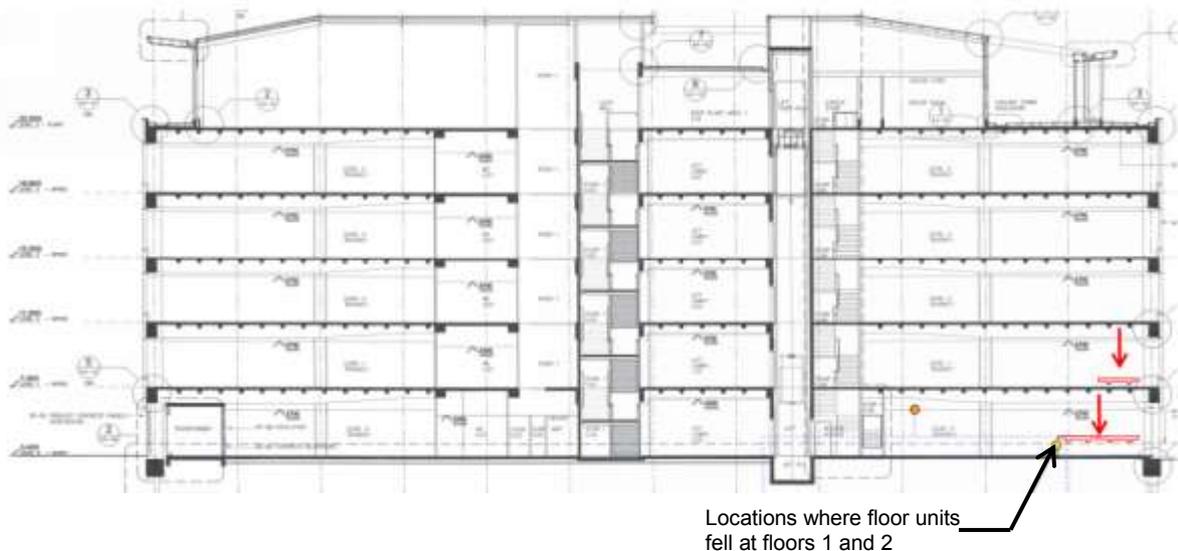
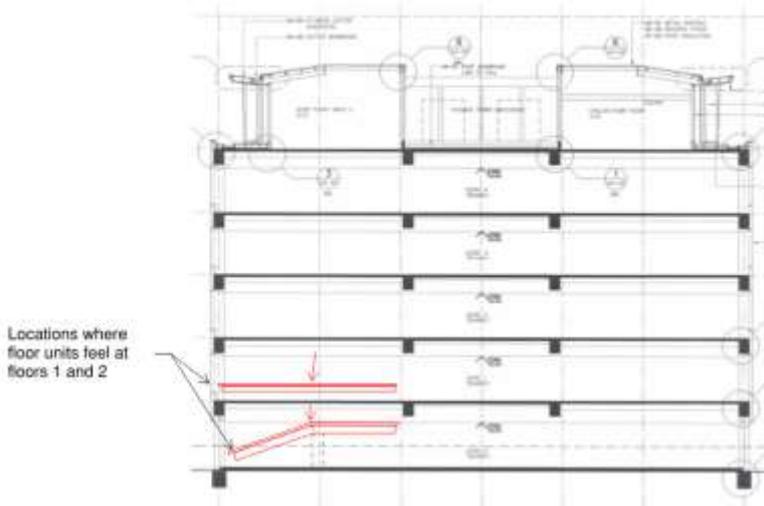
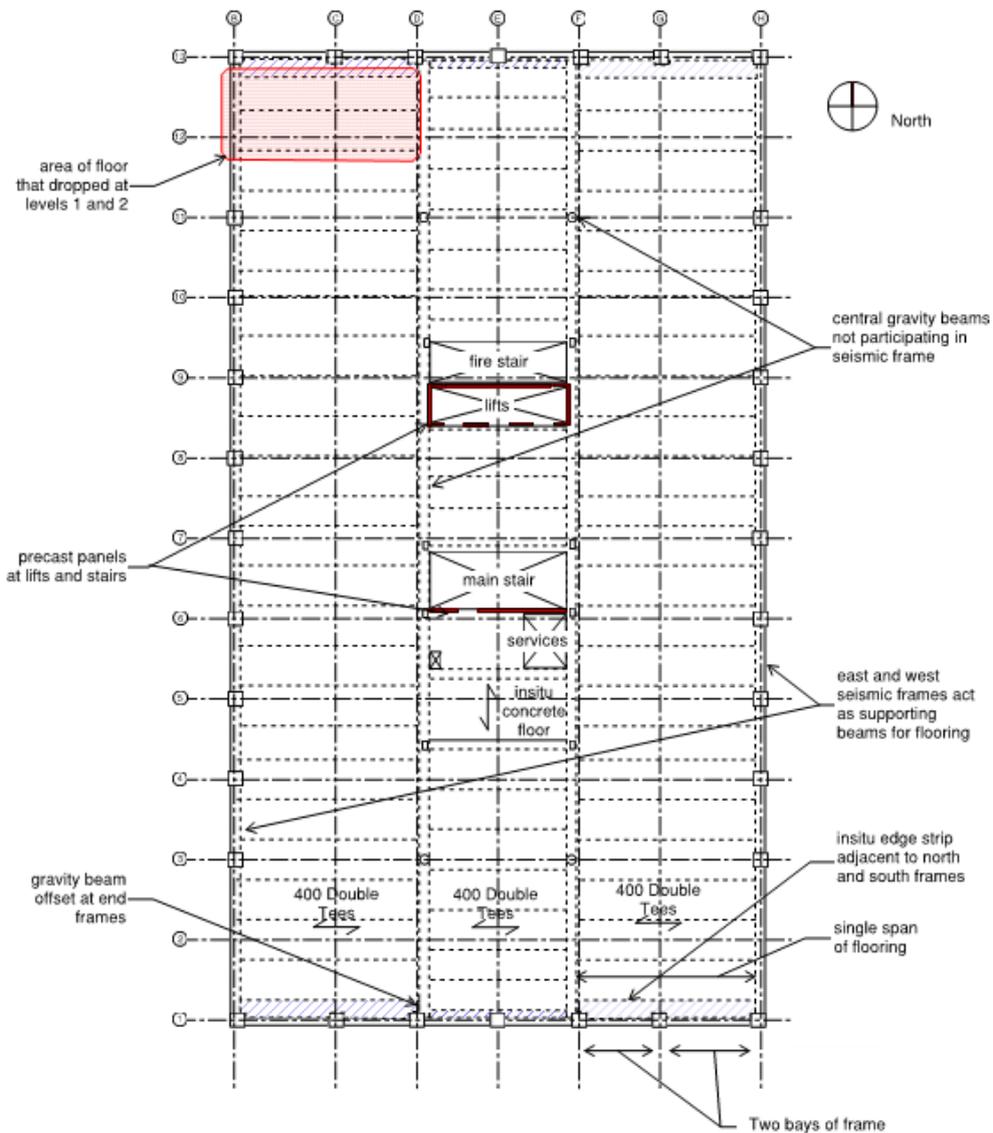
Statistics House is a six storey rectangular building with a footprint area of approximately 58m x 32m (Figures 2, 3 and 4, which also show the extent of damage). The lower levels are of reinforced concrete construction and the top storey is a lightweight steel structure that contains plant and storage space.

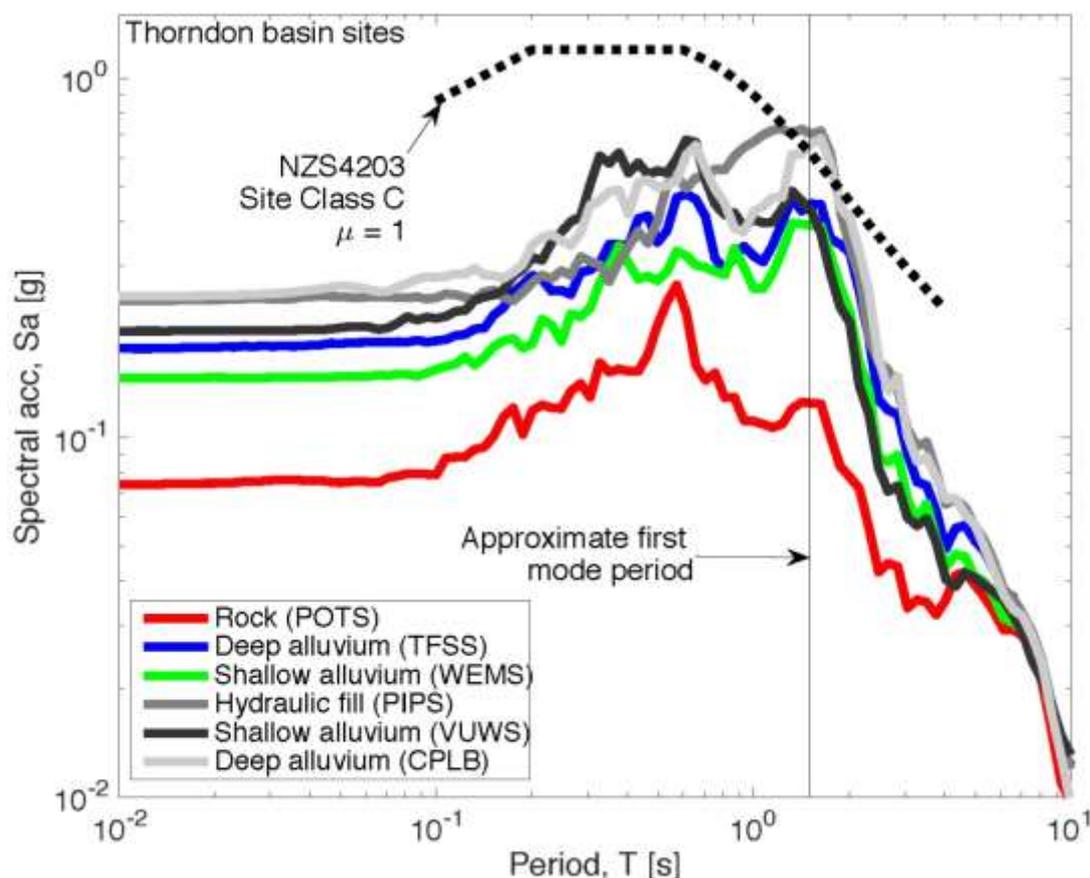
Figure 7: Geometric mean response spectra at strong motion stations located in Thorndon Basin relative to strong motion station on rock, for $S_p=1$

Because of the long distance from the point of rupture to Wellington (source-to-site distance) the short period shaking was largely filtered out. Figure 7 shows the mean response spectra derived from the records of strong motion stations located on soil within the Thorndon Basin and a nearby rock site (POTS) for the 14 November earthquake. All of the soil sites exhibit appreciable amplifications across a wide range of vibration periods. The ground motion intensities relative to both the standard for design (NZS4203) cited in the Building Code Verification Method and to the current cited standard (NZS1170.5) spectra for a deep soil site, are largest over the range of approximately $T=0.6-2.5$ sec. This dominant longer period motion affected mainly buildings with a natural period of 1.0-2.0 sec (typically 8-15 storeys, but as low as 5 storeys for buildings with highly flexible frames).

Figure 13 shows that amplification of longer period ground motions, particularly between 0.6 and 2.0 seconds, occurred at the two Thorndon Basin strong motion stations located nearest to the Statistics House site (and others in the Wellington region, refer Figure 7). This amplification has been observed at both stiffer and softer soil sites (NZS1170.5 site subsoil classes C and D) and basin-edge effects have been identified as a potentially significant factor. Neither the previous loadings standard NZS4203 nor the current earthquake actions standard NZS1170.5 require basin-edge effects to be considered.

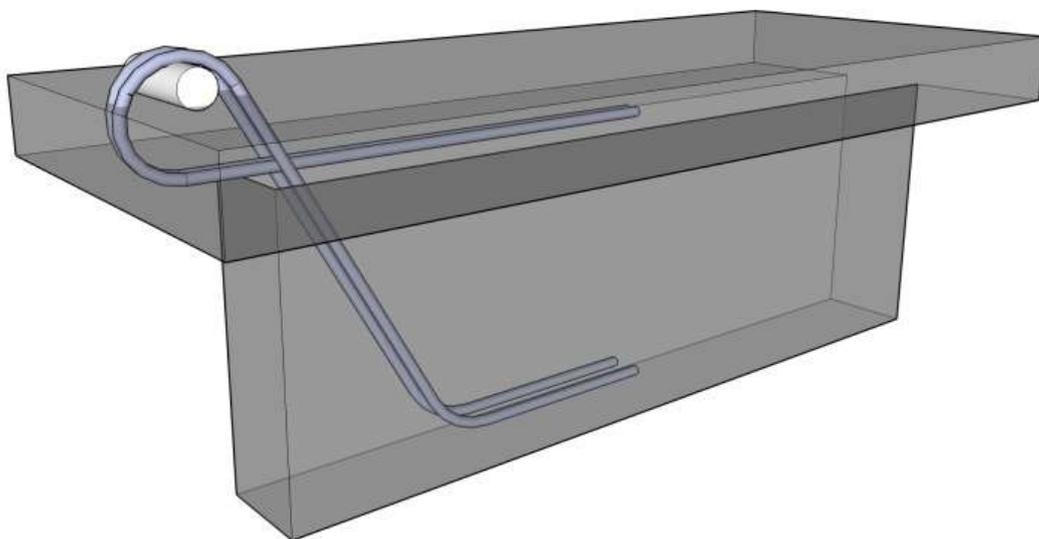
Figure 16: Loop bar hanger in precast double tee unit

The double tee unit has a loop hanger (commonly referred to as a pigtail): a pair of plain round bars looped at each rib and embedded back into the ribs, with a short length of 20mm round reinforcing bar inserted through the loop bars (Figure 16). The loop bars project from the double tee precast units and are cast into the concrete topping, although without a positive connection.

The failures consistently showed the outer edge of the nib breaking off, generally at the end of the loop bar, and in some locations, a small amount of spalling to the supporting beam ledges. This had the effect of shortening the floor units at the same time as the beams were elongating. This failure sequence is illustrated in Figure 17. The length of seating actually achieved during construction would have had no effect on this form of failure, as it is determined by the geometry of the loop bars, not the nib length.
